FOUNDATION ENGINEERING, INC.

Re: Structural Inspection of the residence located at:
6710 E. 75th Court
Tulsa, OK

On Tuesday, August 18, 2020, I made an engineering inspection of the residence at the above location as you requested. The purpose of the inspection was to detect any defects that might exist, discuss apparent causes of the damage, and make recommendations for repair and prevention of further damage to the property. Please note that all observations and recommendations are strictly my professional opinion and may differ from those of other professionals. This inspection report may be revised as new information about the house become available.

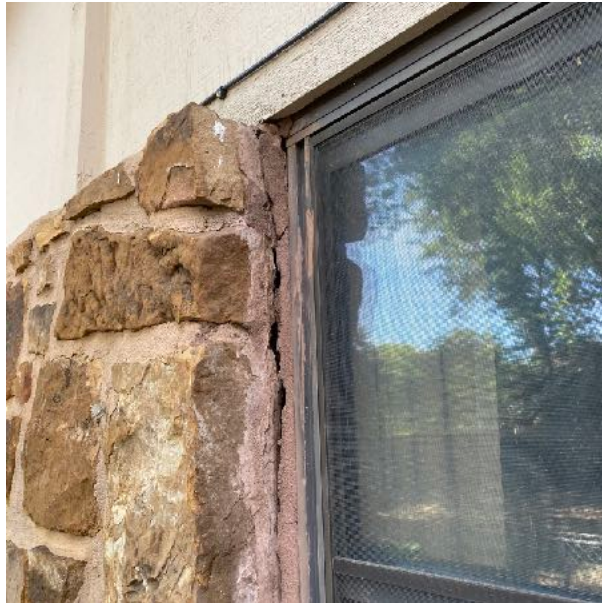
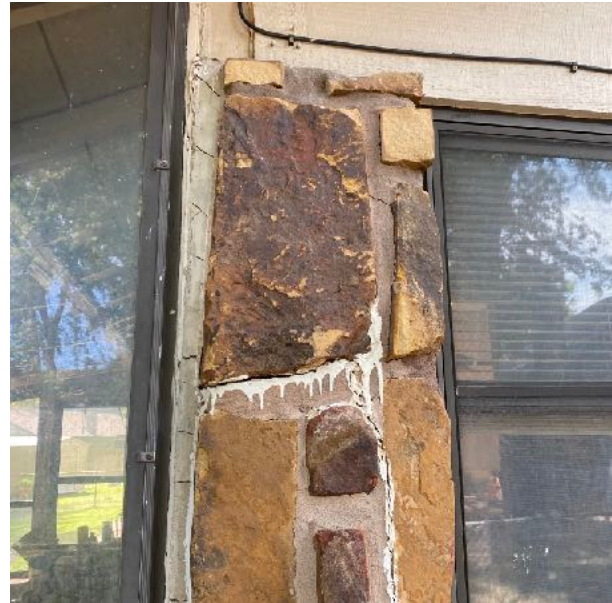
The exterior stone veneer around the house was inspected and indicated cracks and separations along the walls of the house. Examples occur around the garage door, on west and east sides of the house and along the exposed concrete foundation. These cracks and separations are due to foundation movement under the perimeter walls of the house.

Other cracks and separations on the exterior veneer, and uneven floors and cracks at the interior of the house are due to minor floor slab and foundation movement under the house. This movement has not affected the load bearing capacity of the structure and it is not severe to warrant any repair at this time. Foundation stabilization in the form of underpinning (piers) or foam injection will be necessary if further floor and/or foundation movement (settlement) continues in the future.

1- Tuck pointing the cracks and gaps in the exterior stone around the house is recommended. This repair is to be completed by a qualified mason, and the repair is to aesthetically match the existing exterior veneer.

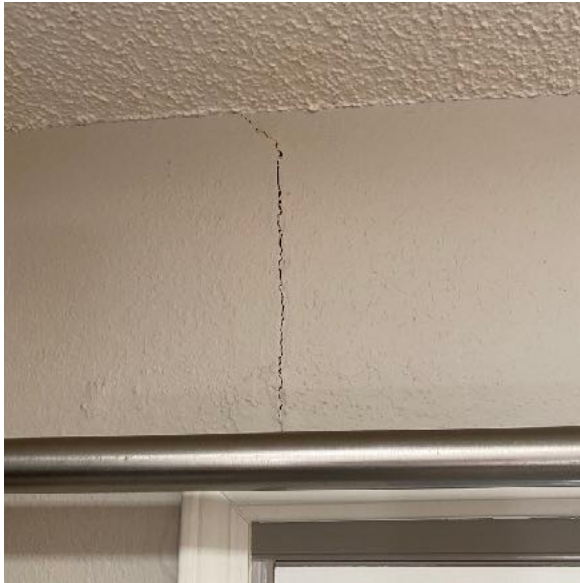
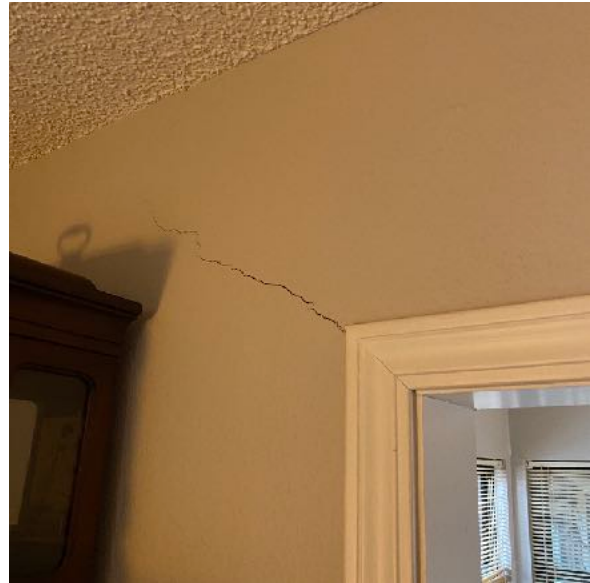
The interior of the house was inspected and indicated cracks on the interior and perimeter walls. Examples occur below the south window in the master bedroom, and above the master bathroom door. Substantial uneven floors were noticed throughout eastern portion of the house. These cracks and uneven floors are due to floor slab settlement and foundation movement. Interior floors were checked for cracks, settlement, heaving, separations and none were apparent (due to floor coverings, wood, tile, carpet, etc., floor surfaces may not be observable).

The cracks and separations in the garage, and along east and southeast corner of the house, and uneven floors in the kitchen and living room indicate that foundation and floor slab movement has occurred at this residence. Stabilization of the floor slab and walls (per attached drawing) is recommended.

3- Stabilization of the interior floor slab is recommended at the location shown on the attached drawing. Two options exist for stabilization of the floor slab: underpinning the slab with steel piers or stabilizing the slab with foam injection.

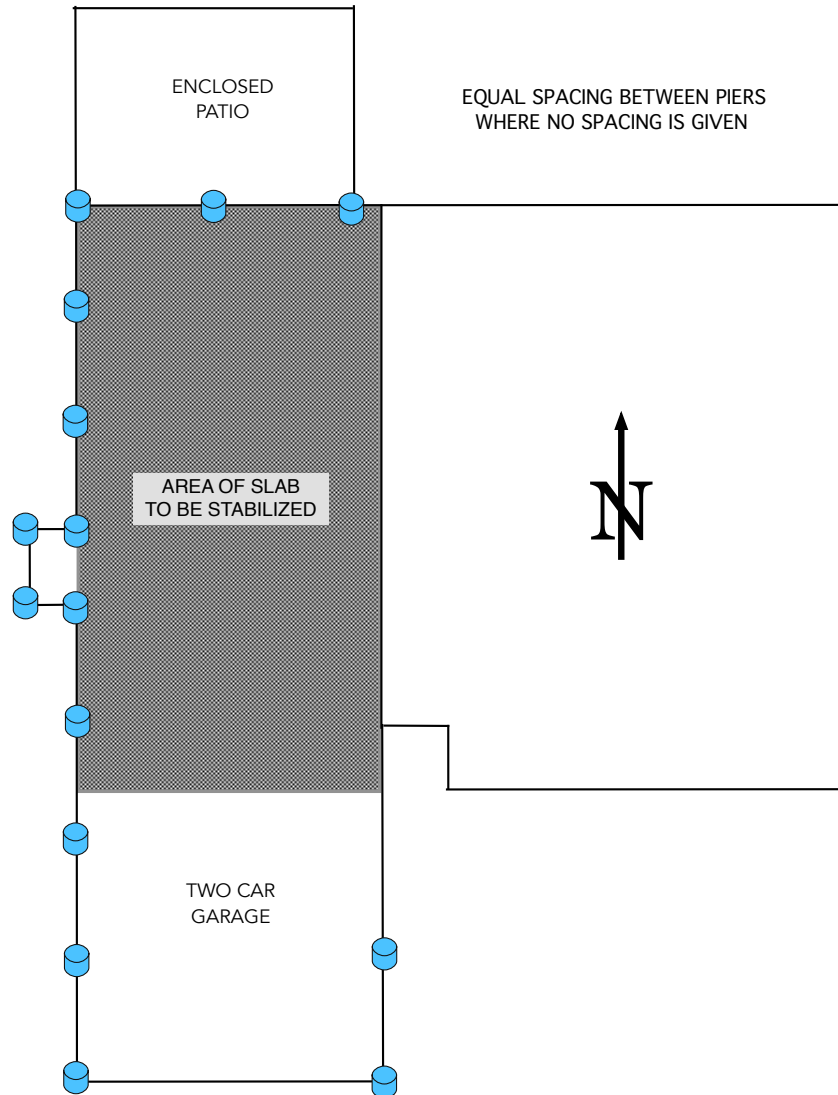
PIER LOCATION PLAN NOT TO SCALE

WHERE PIERS FALL IN THE VICINITY OF
A CRACK, AN ANGLE IRON (6"X6"-1/2")
NEEDS TO BE PLACED UNDER THE CRACK
PRIOR TO LIFTING

FOUNDATION PIERS
NO. RECOMMENDED 15

2- Underpinning of the perimeter walls with piers (see attached drawing) is recommended to stabilize the foundation at the pier locations. Please note that the piers are located where foundation movement/settlement is severe. All piers are to penetrate a minimum of 12 feet below the bottom of the foundation to a firm, stable strata below. The contractor is to provide a pier log showing the depth, type, diameter, driving pressure, and amount of lift at each pier location. If there are existing shallow concrete piers under the foundation at a location where new piers are recommended, please contact our office for further direction. Prior to piering, the mortar in all patched cracks in the vicinity of the piers is to be removed.
