FOUNDATION ENGINEERING, INC.

Re: Structural Inspection of the residence located at:
6710 E. 75th Court
Tulsa, OK

On Tuesday, August 18, 2020, I made an engineering inspection of the residence at the above location as you requested. The purpose of the inspection was to detect any defects that might exist, discuss apparent causes of the damage, and make recommendations for repair and prevention of further damage to the property. Please note that all observations and recommendations are strictly my professional opinion and may differ from those of other professionals. This inspection report may be revised as new information about the house become available.

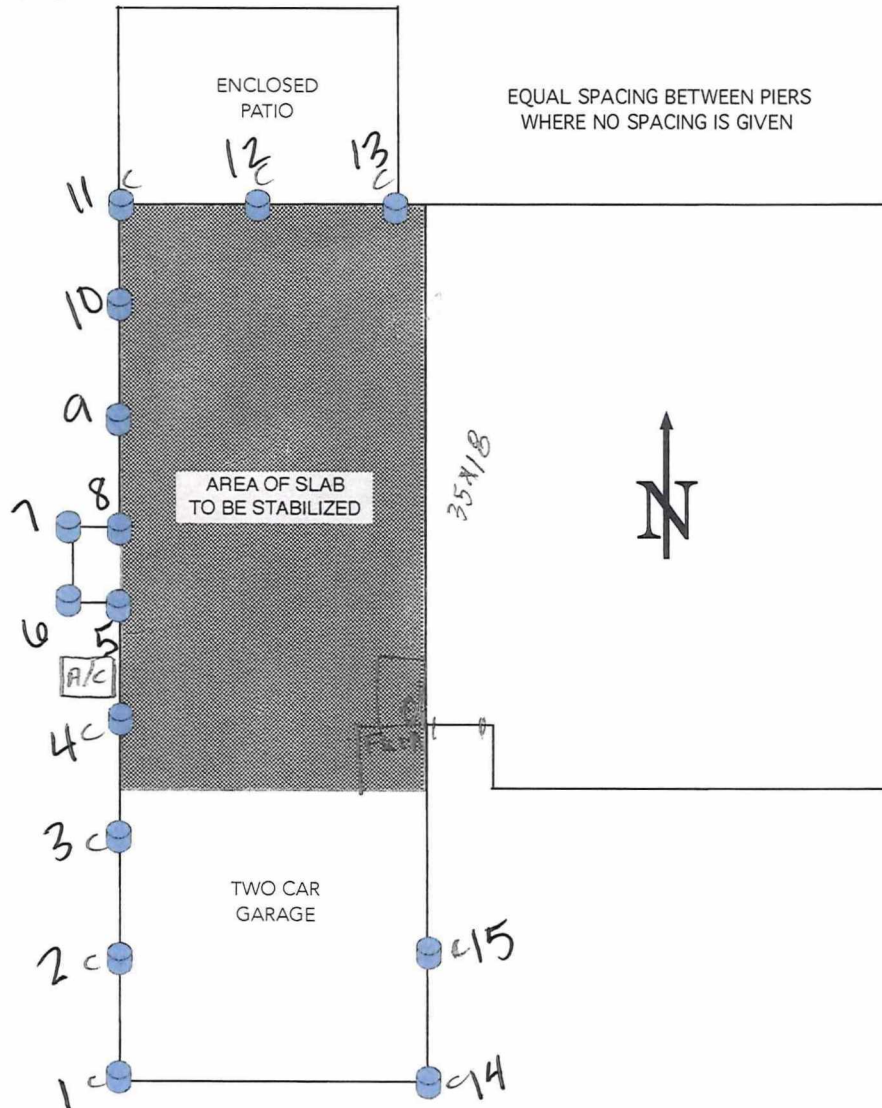
PIER LOCATION PLAN NOT TO SCALE

The cracks and separations in the garage, and along east and southeast corner of the house, and uneven floors in the kitchen and living room indicate that foundation and floor slab movement has occurred at this residence. Stabilization of the floor slab and walls (per attached drawing) is recommended.

2- Underpinning of the perimeter walls with piers (see attached drawing) is recommended to stabilize the foundation at the pier locations. Please note that the piers are located where foundation movement/settlement is severe. All piers are to penetrate a minimum of 12 feet below the bottom of the foundation to a firm, stable strata below. The contractor is to provide a pier log showing the depth, type, diameter, driving pressure, and amount of lift at each pier location. If there are existing shallow concrete piers under the foundation at a location where new piers are recommended, please contact our office for further direction. Prior to piering, the mortar in all patched cracks in the vicinity of the piers is to be removed.

3- Stabilization of the interior floor slab is recommended at the location shown on the attached drawing. Two options exist for stabilization of the floor slab: underpinning the slab with steel piers or stabilizing the slab with foam injection.

WHERE PIERS FALL IN THE VICINITY OF A CRACK, AN ANGLE IRON (6"X6"-1/2") NEEDS TO BE PLACED UNDER THE CRACK PRIOR TO LIFTING
